PROJECT NAVARA

TAKE AN OLD UTE,
BRING IT BACK TO TOP
SPEC STANDARDS
AND YOU'VE GOT GREAT LOOKING
TRANSPORT ON A
LOW BUDGET

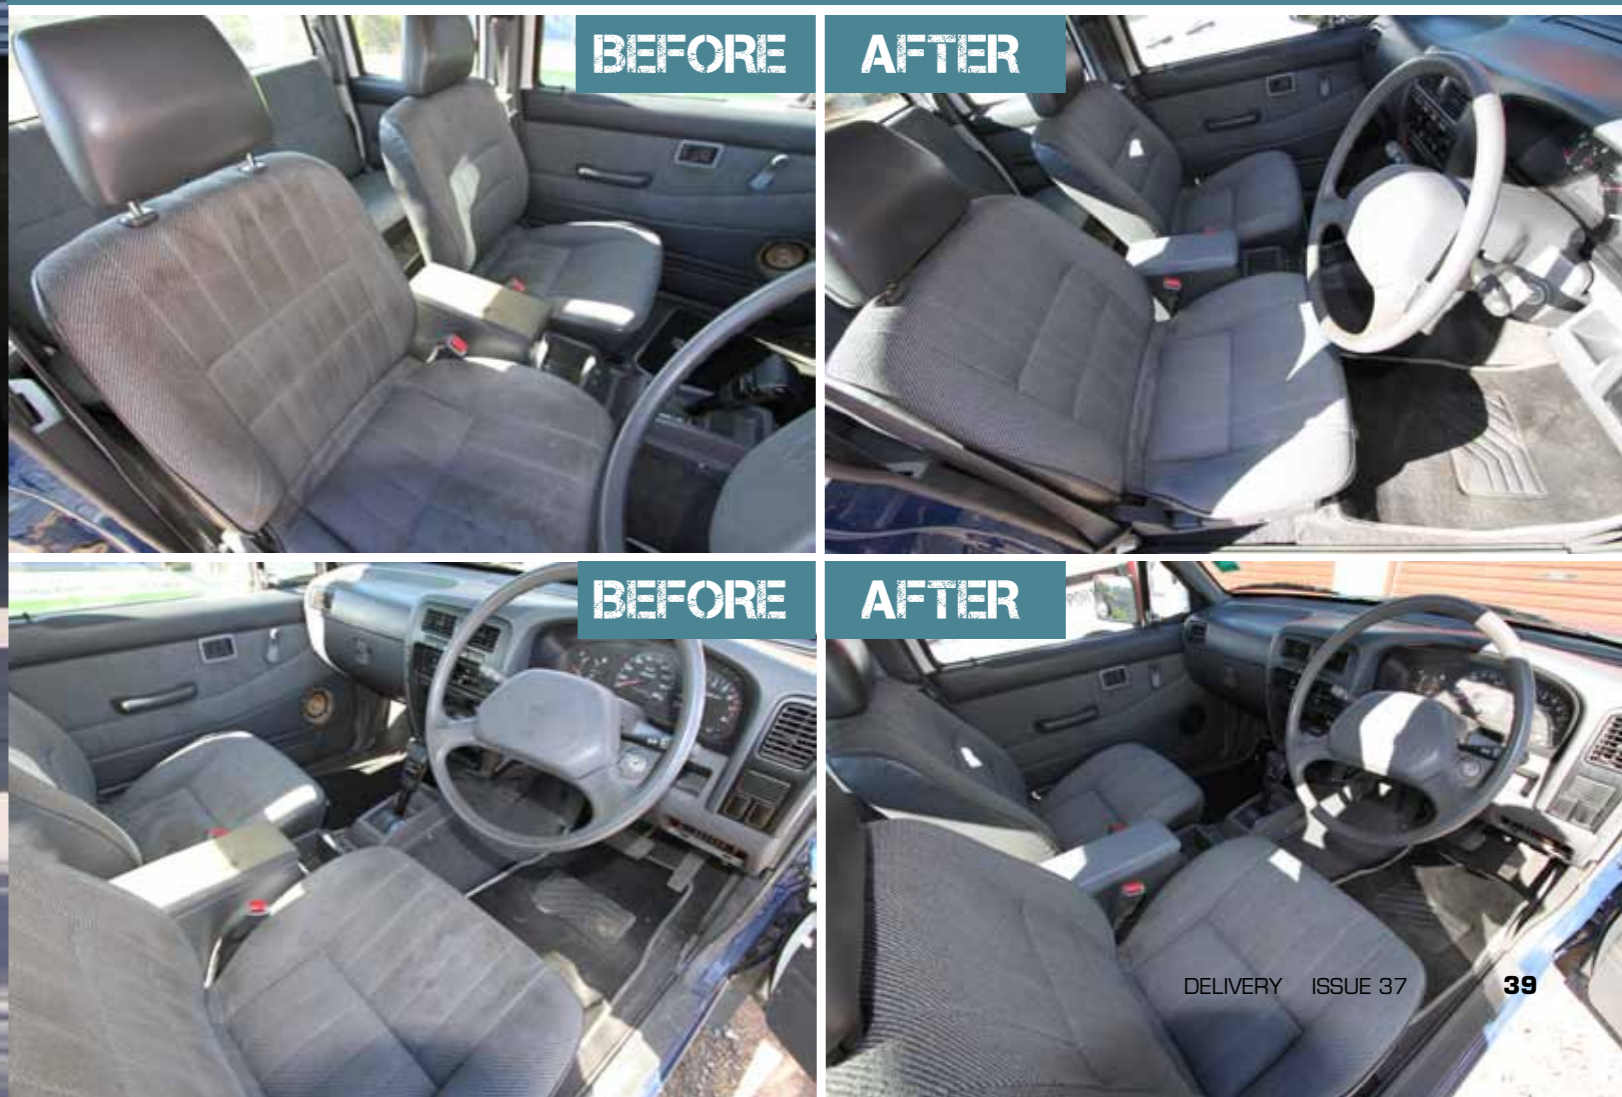
A well executed detailing programme can remove years of neglect and turn even an older vehicle into a highly desirable project to enhance appeal and resale value. Removing ingrained dirt from 16 years of hard work has transformed the Navara.

Whereas the paintwork needed tender loving care, the interior, with its accumulated 16 years of dirt and grime from overalls and worksites, needed to be virtually steam cleaned throughout. The same applied to the door trims and carpets.

Our blue and white Navara was treated to probably the auto equivalent of a health spa with a full body cleansing, buffing, steam cleaning and general spruce up. A pair of new radio speakers in the doors enabled the radio to show it could still work without needing to be replaced, and this also raised the appearance of the interior, substantially. The centre console lid was re-trimmed in matching grey vinyl, and this also made a big difference to first impressions.
